Eagleville Elementary School Facade Investigation

August 2019

Introduction

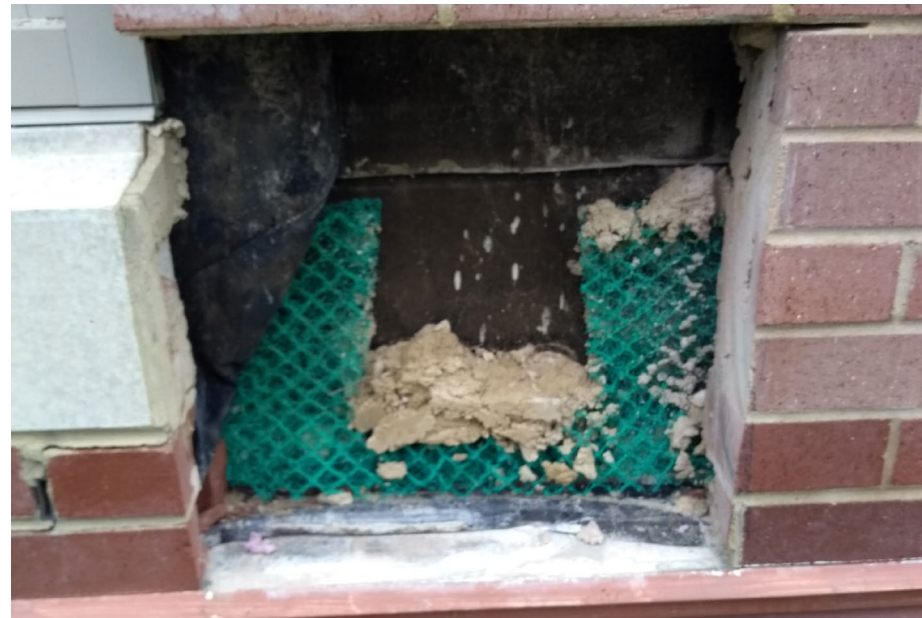
On the east side of the building, dual level mortar net was observed at the window heads, sills and at the top of the mechanical vents. The mortar net was installed properly with no issues noted. On the west side of the building at the south end, a single level mortar net was installed. This mortar net was not as thick and did not fill the cavity. As mortar droppings fell on the net during original construction, the mortar net compressed under the weight of the mortar causing it to bunch up at the bottom. The mortar net was nearly full of mortar in some spots making it ineffective. At Probe Location #21, bees had made a nest in the mortar net that was the entire height of the mortar net and approximately three feet long. Moving north along the west side of the building, the mortar net was not installed.

Dual level mortar net.

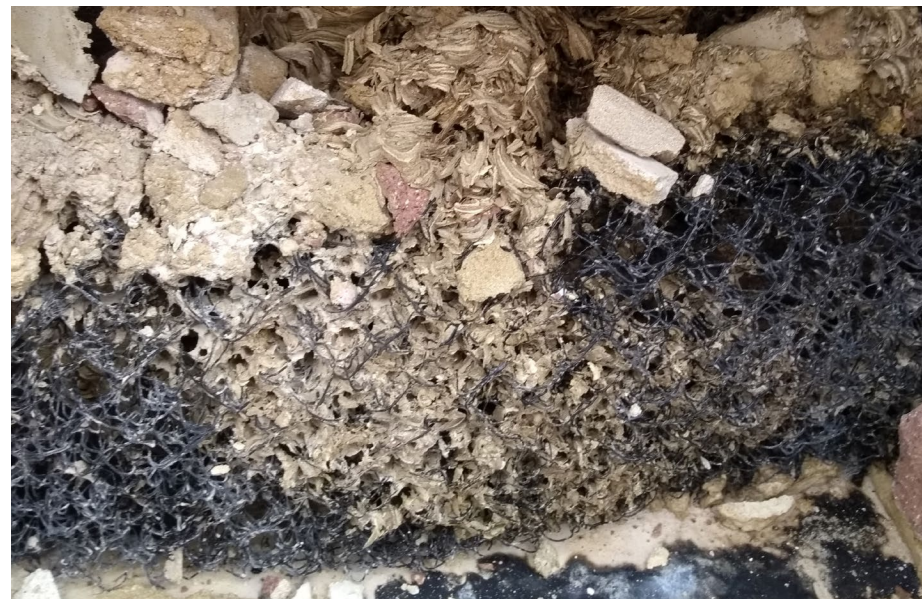
Single level mortar net.

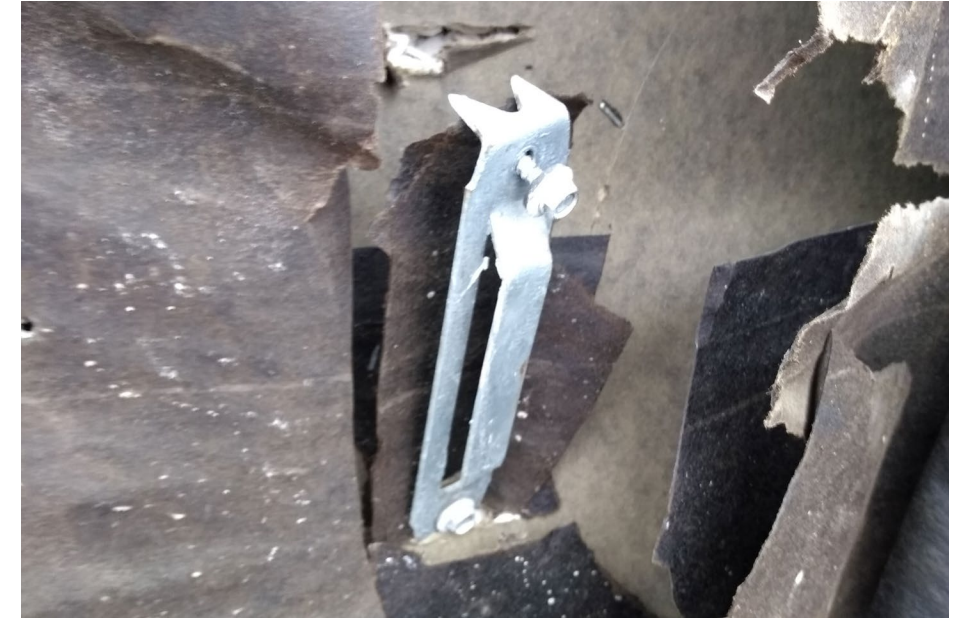
The greatest concern documented regarding the existing construction was the installation of the masonry ties at the stud wall construction portion of the building. Many of the ties were found only to be anchored into the sheathing

Masonry tie not secured into structural wall.

We recommend that the stud construction portion of the building be completely re-clad in a new veneer material. This will mean that all of the brick veneer will be removed from the facades and a new veneer system installed. The removal of the existing veneer system will allow for the sheathing to be repaired as needed, a more consistent vapor barrier installed and all new flashings to be installed to work properly. New masonry may be installed at the lower four feet of the building to protect against impact from landscaping activities.

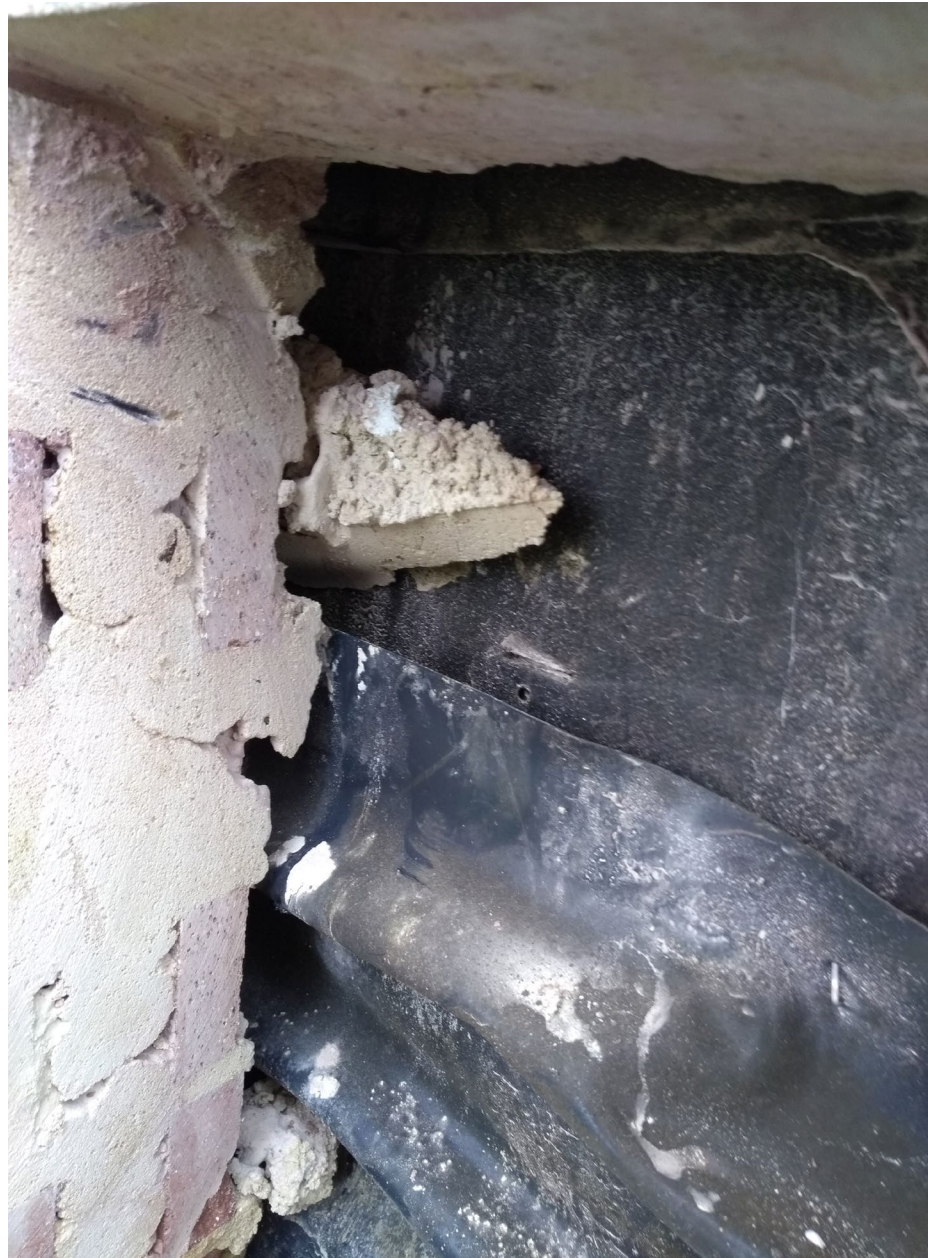
Flashing loose laid in wall with anchoring at the top. Does not direct water out of wall.

Vinyl flashing has been found at most of the window heads, sills, vents and coping. In a few locations, no flashing was found. At these locations, two layers of building paper was used in lieu of the vinyl flashing. The height of the flashing varies and is sometimes lower than the top of the cast stone headers. The vinyl is not adhered to the sheathing and rarely has any mechanical fasteners allowing the rubber to droop down and not perform properly as flashing. At Probe location #25, muck was used to attempt to the glue the flashing to the metal structure and then go thru the brick joint in the wall. Very little muck was used so it has become unglued and the flashing is just laying in the joint not tied to the interior of the wall. At the top of the wall, the flashing was installed inverted so that the interior leg of the flashing is downward and doesn't allow the water to be directed to the mortar joint.

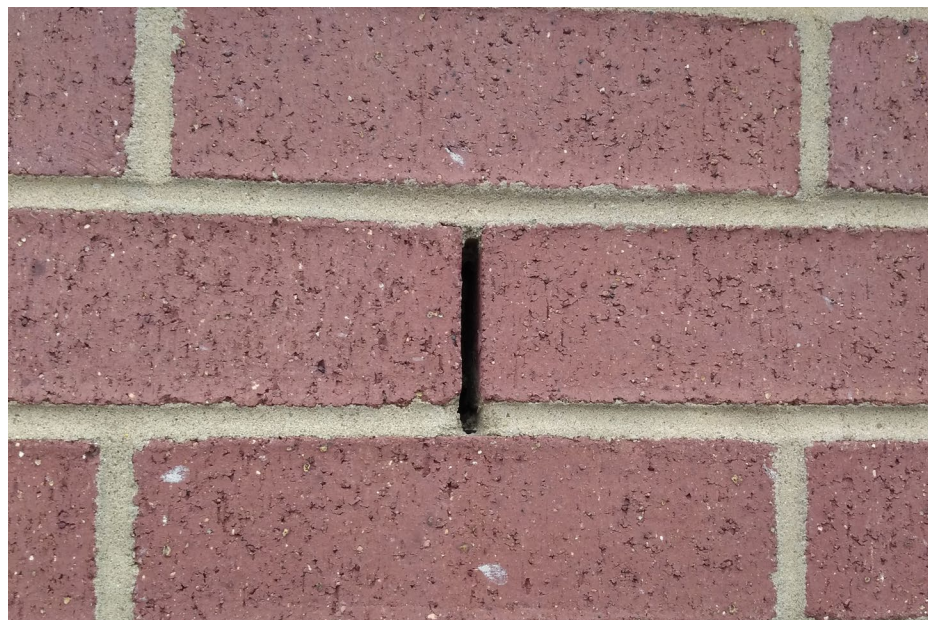
Mortar left out of joint, but plastic weep not installed.

Open plastic weeps were installed at window heads, sills, vents, floor level and top of wall. Many of these were observed to be broken. Since they are open, many bees and other insects have permeated the wall and made their home in the wall cavity. Staff have observed bees and other insects in the classrooms. Weeps were found at locations closer to the ground; however, those located higher in the wall (where it cannot be easily observed), the weeps do not appear to have been installed and mortar was intentionally not installed in the head joint to give the appearance of an open weep.

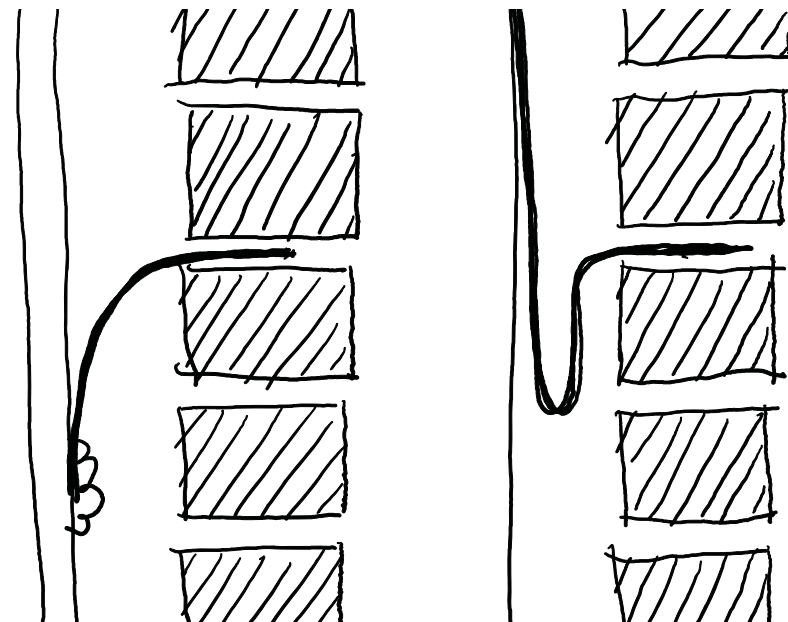
Diagram of existing flashing conditions showing inverted flashing and creating a pocket .

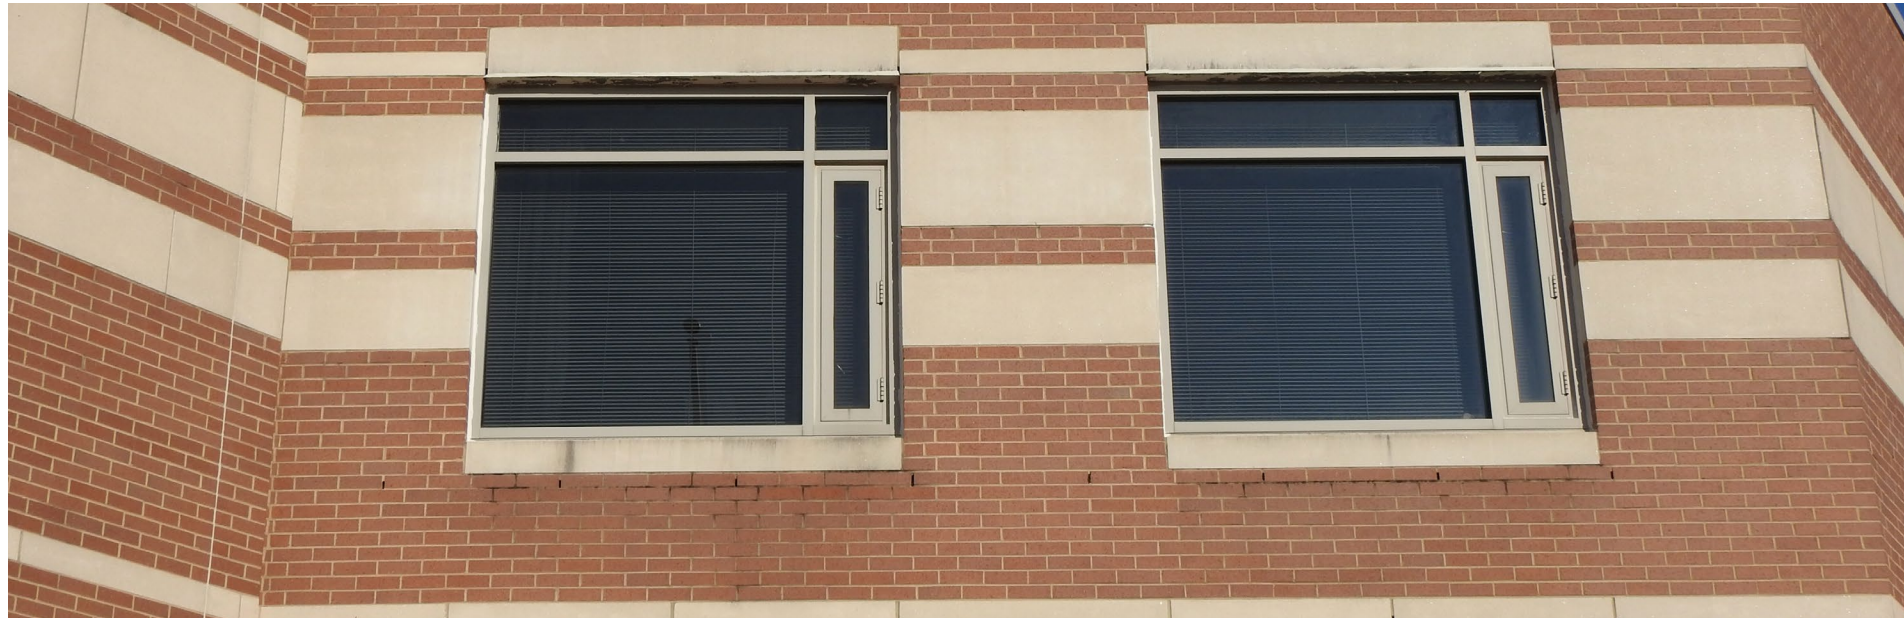
Dark biological staining under windows showing possible water infiltration areas.

Biological soiling is black or green soiling on the masonry that is the result of biological (mold/ moss/ mildew) growth. Biological growth is typically found on the north side of the building and at locations where the wall is holding water which encourages biological growth. Biological growth was observed under some window sills. This indicates the possibility that the wall is holding water in these locations. This condition supports the observation that the flashing does not direct the water out of the wall.

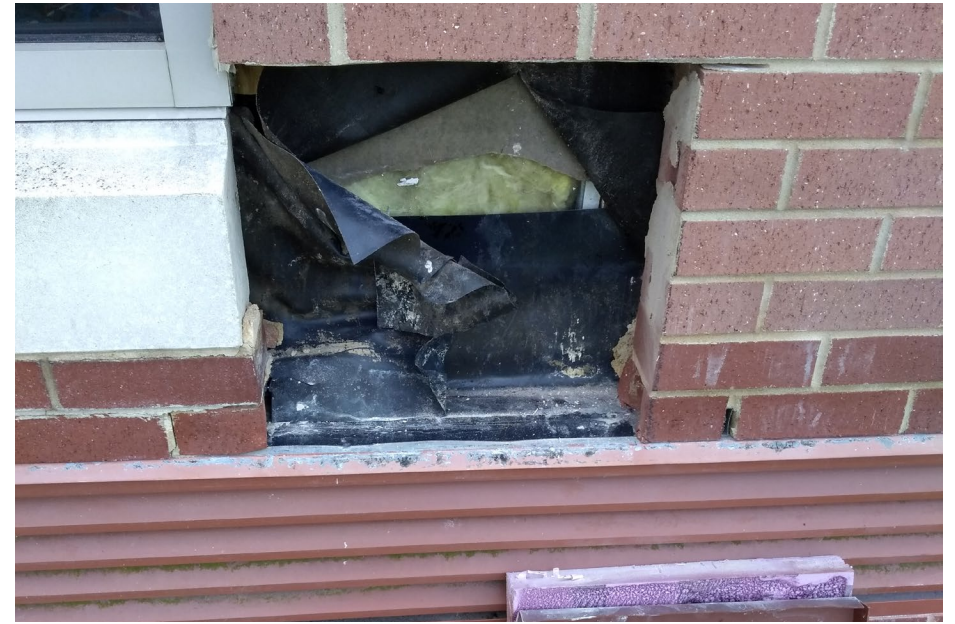
Insulation exposed because sheathing does not extend to bottom of wall. (Probe 5)

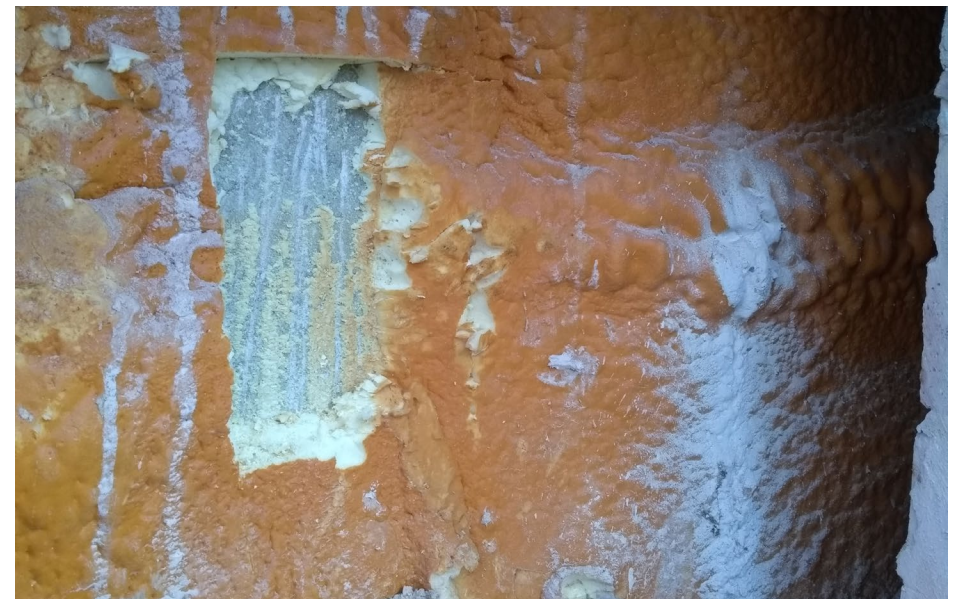
On the CMU portions of the building, spray foam insulation was applied to the CMU as per the original construction specifications. The drawings call for 2" of insulation applied directly to the CMU. The thickness of the existing spray foam varies from 1/2" to 1-1/4". Varying coverage makes it impossible for the spray foam to provide the intended added R-value to the wall. The spray foam was scraped from the CMU in one location to review the CMU behind it. The spray foam was applied without a vapor barrier. Neither the foam nor the CMU showed signs of water staining or mold.

Spray foam insulation less than 1/2" thick. (Probe 18)

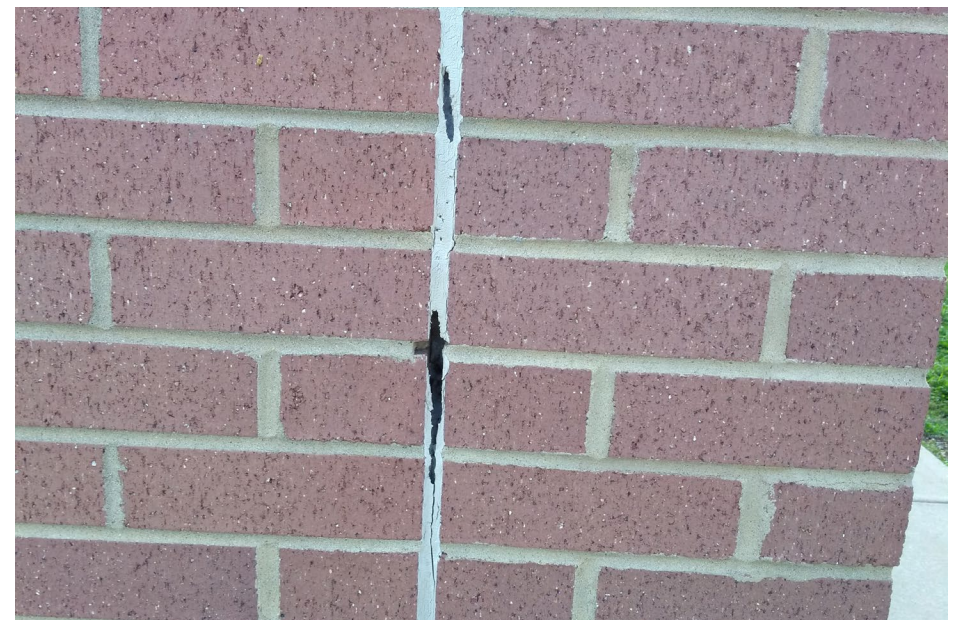
Vertical control joints have been provided in the brick veneer to allow for expansion and contraction. The existing sealant in these joints is beyond its serviceable life. The sealant is pulling away from the brick and allowing water to enter the building. The sealant should be replaced as part of any repair work completed on the building.

Failed sealant in expansion joint. (West wall)
